Field Findings Report Plum Borough School District Plum High School Softball Field Project

Date:	September 2, 2011 (Date of Field Investigation)
Project:	Proposed Softball Field at Plum High School Project Preliminary Wetland and Surface Water Field Reconnaissance Investigation
Field Staff:	Tammy Sherwin and Kelly Eismont

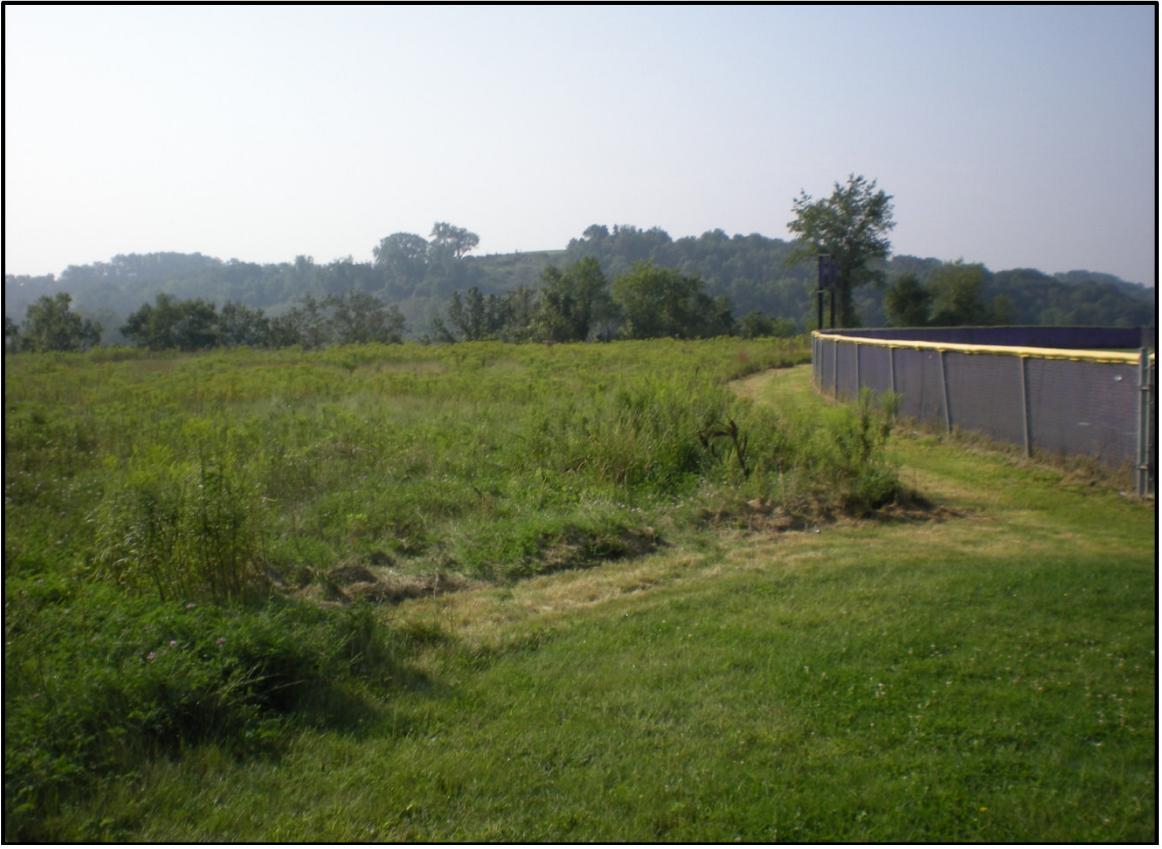
Photograph 1: Looking southeast at the project area along the fence line of the existing ball field.

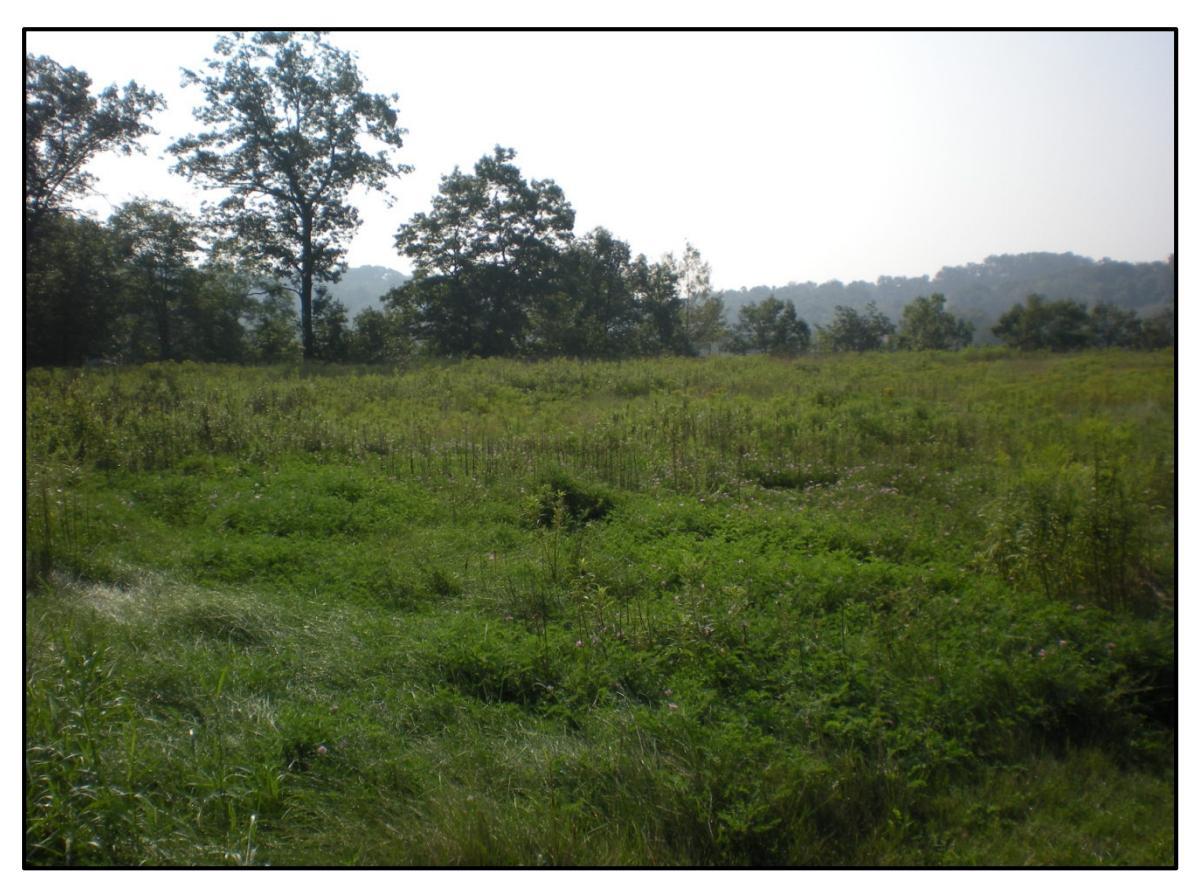
Photograph 2: Looking east at the project area.

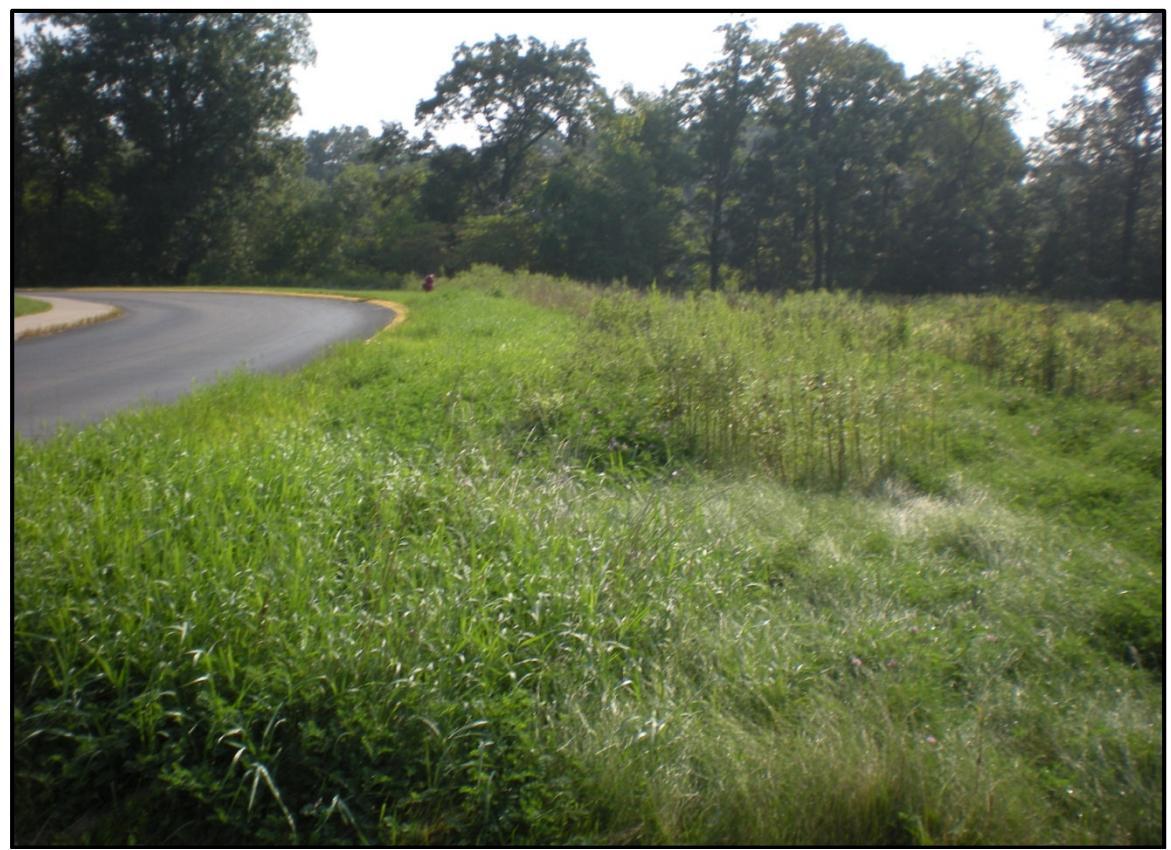
Photograph 3: Looking northeast at the project area.

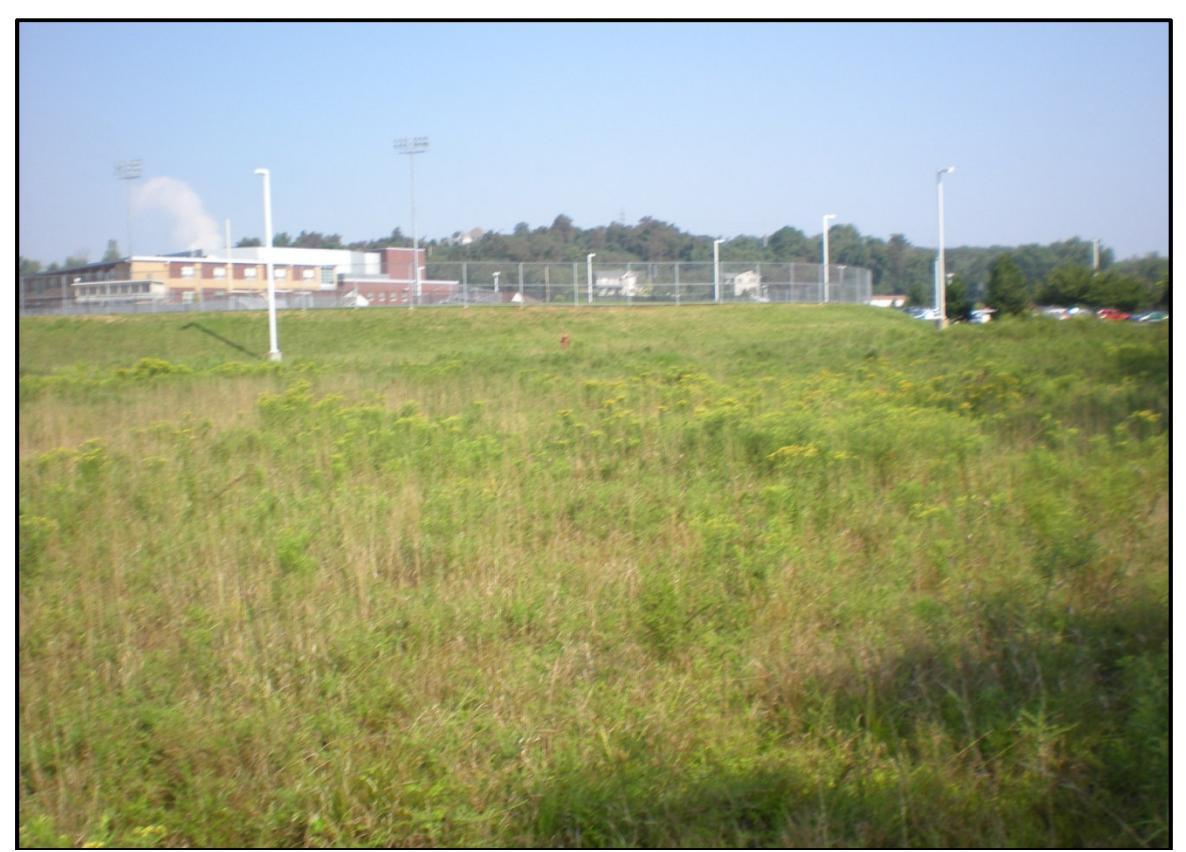
Photograph 4: Looking northwest at the project area.

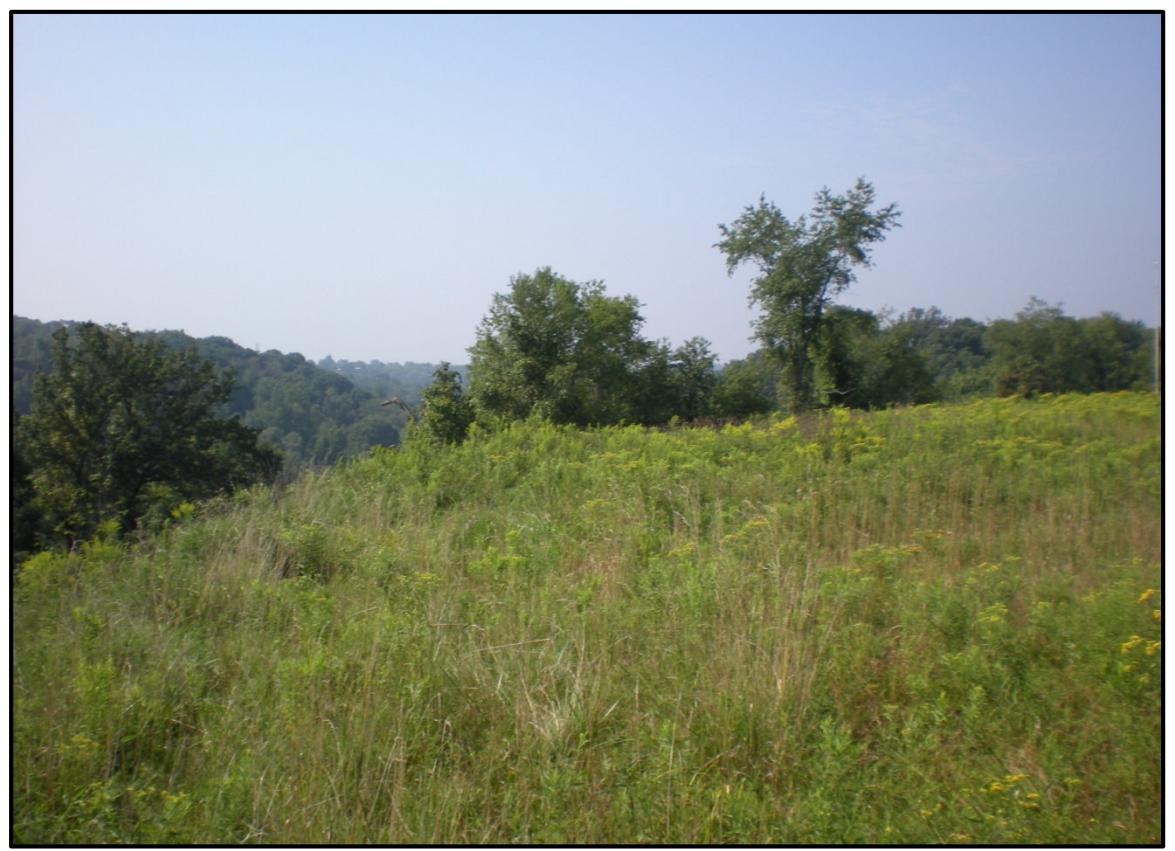
Photograph 5: Looking south at the project area.
